## Vehicle Inspection Report

| <b>Make:</b> | ASTON MARTIN | <b>Date:</b> | 10-11-2025 |
| <b>Model:</b> | DBS | <b>Technican</b> | Abdul Salam |

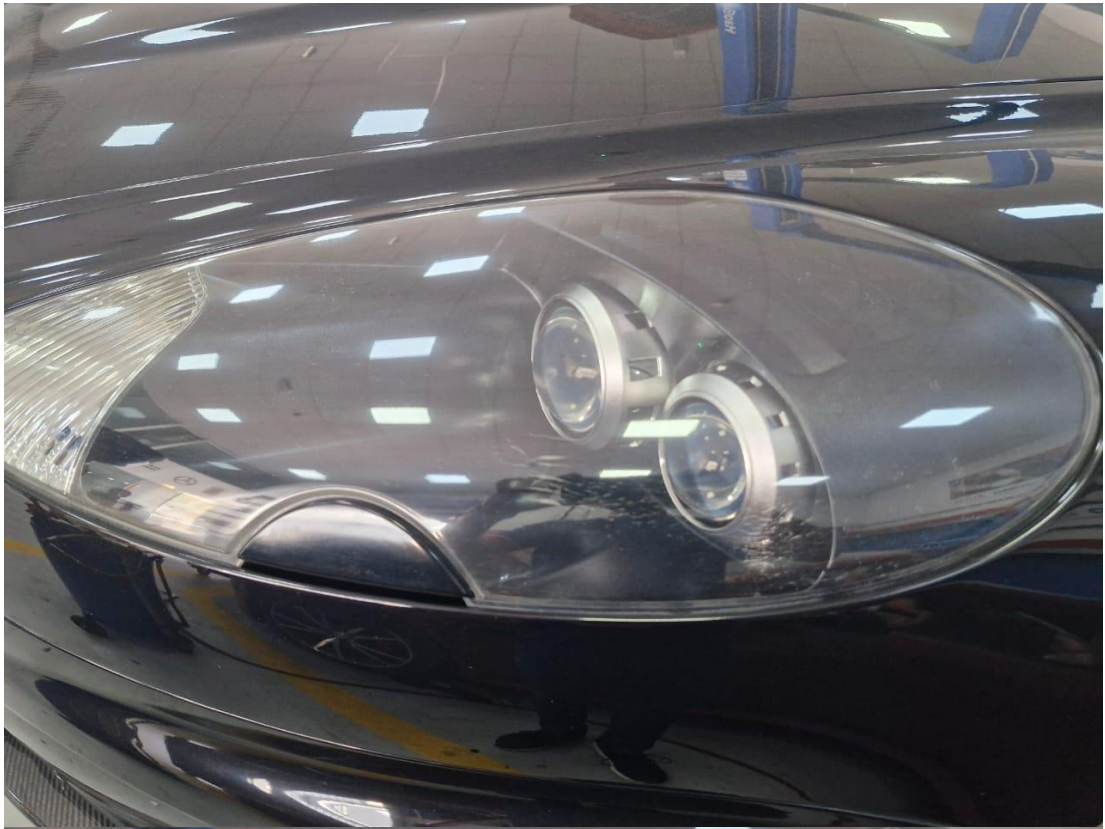
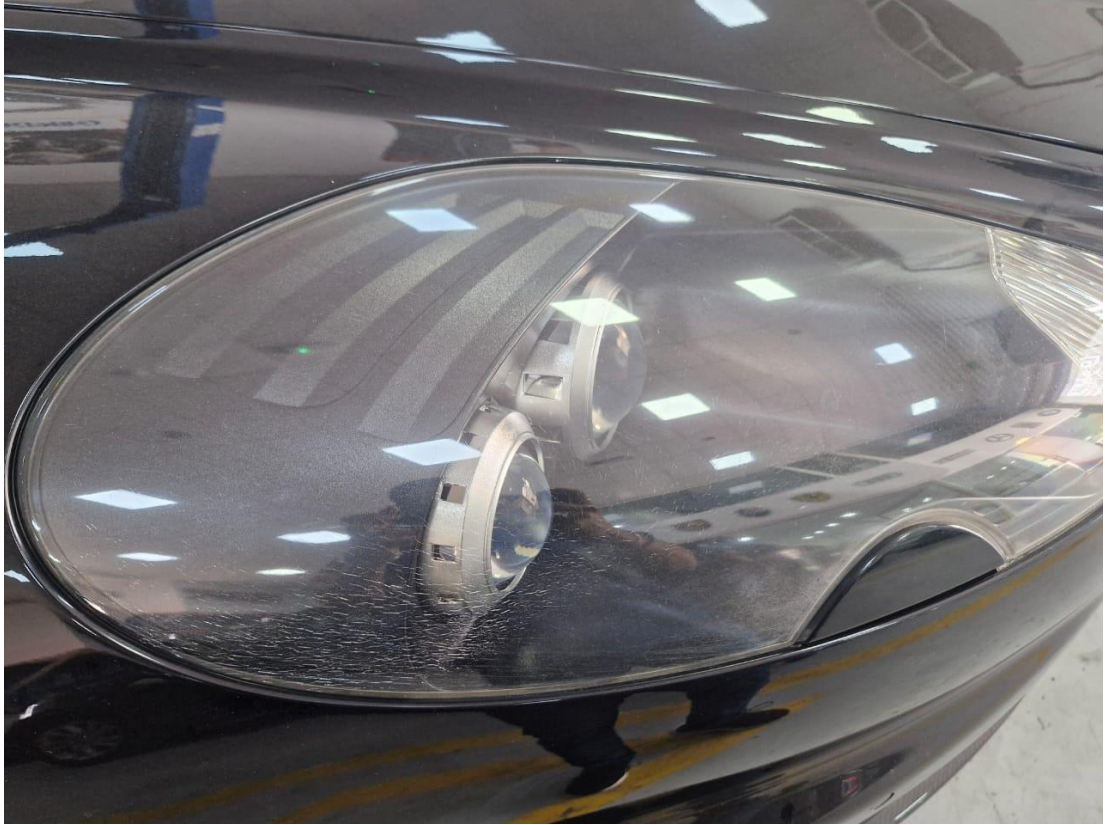
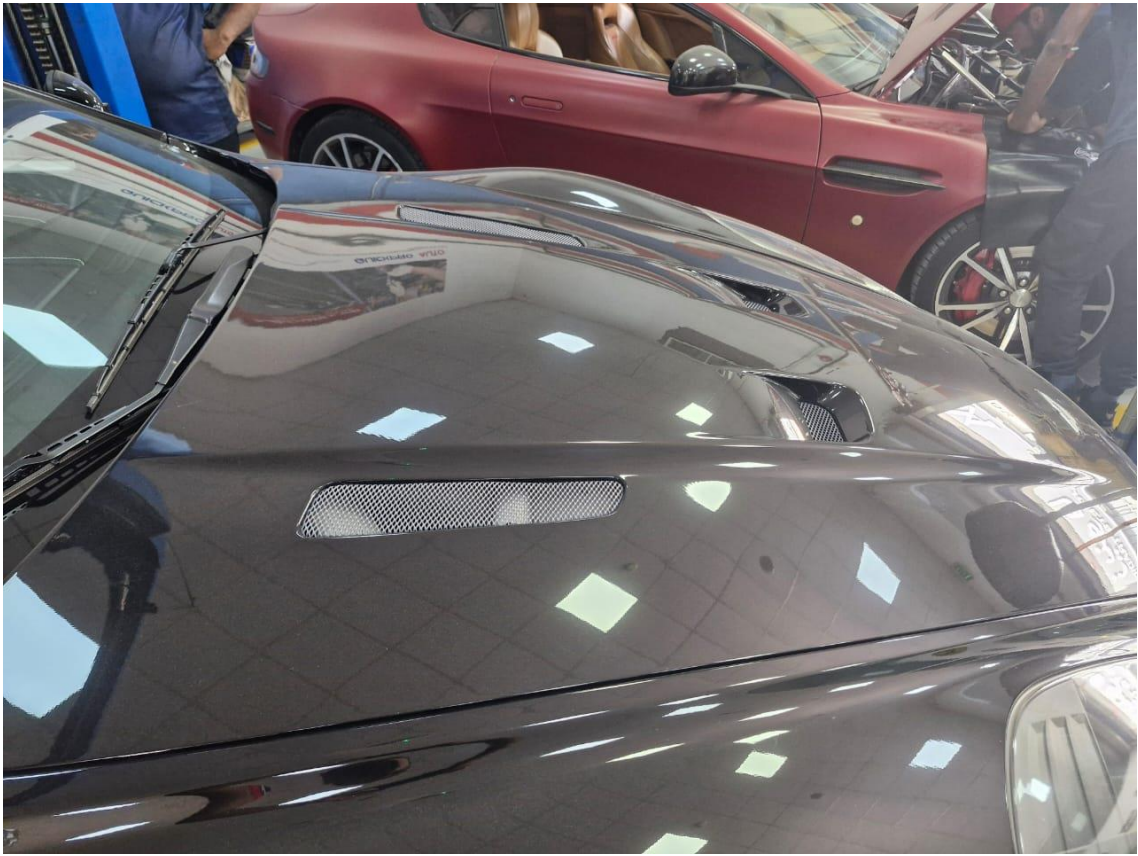
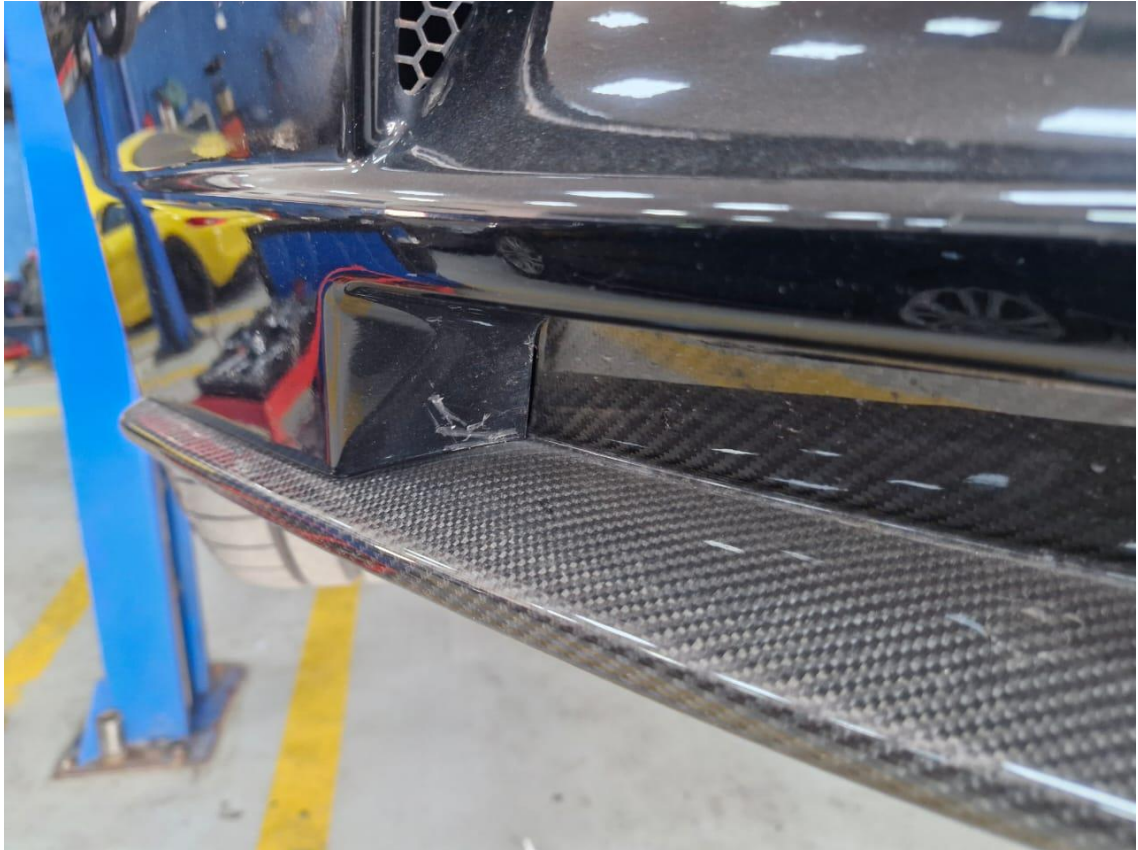
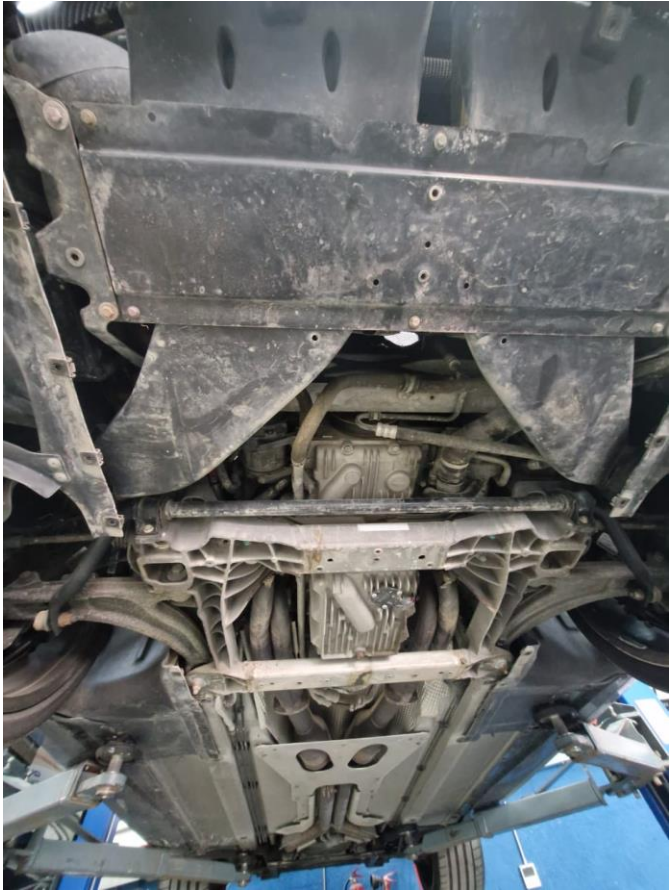
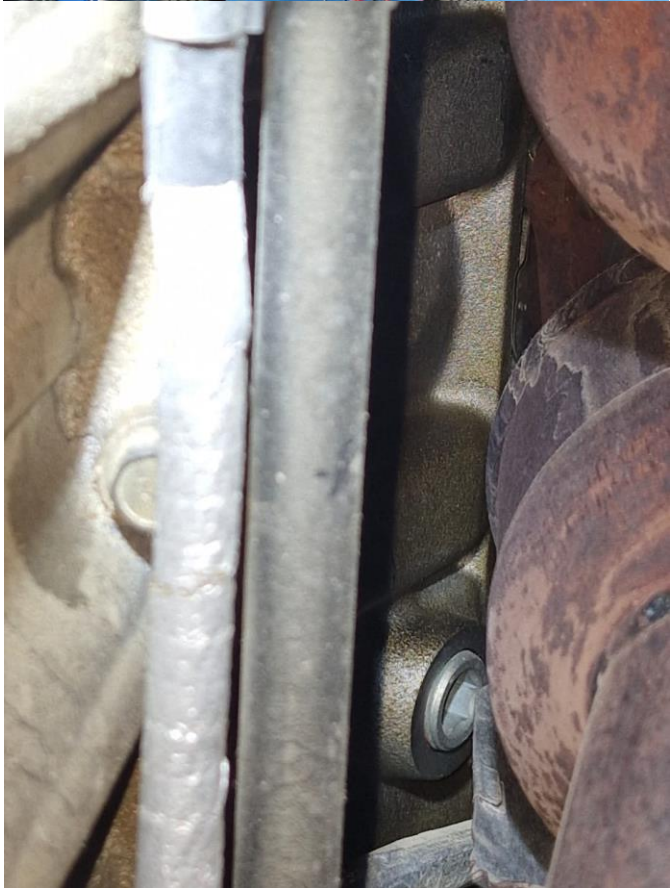
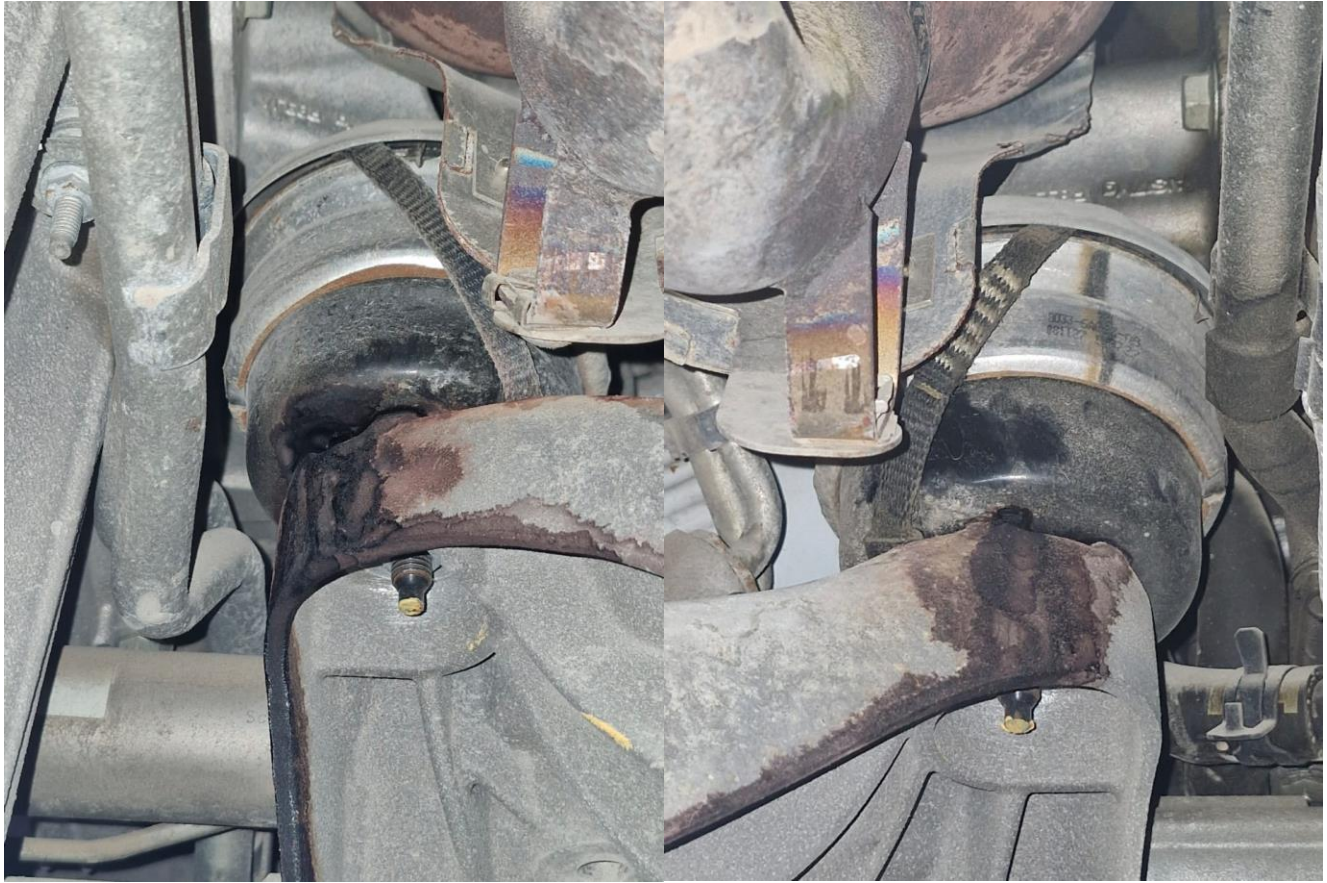
- Body work and paint is in generally good condition with no repaints observed, minor visible scratches on the body. Carbon fibre body unable to confirm if it has been repainted
- Headlight inner film damaged (picture attached). Light is working fine
- Front hood vent mesh slightly missaligned (picture attached)
- Minor damage observed on side skirt (picture attached)
